PHASE I INSPECTION REPORT  
NATIONAL DAM SAFETY PROGRAM

YELLOW WATER MAIN DAM (MT 12)  
AND  
YELLOW WATER DIKE (MT 3205)  
WINNETT, MONTANA  
PETROLEUM COUNTY

PREPARED BY:  
HKM ASSOCIATES  
BILLINGS, MONTANA

SEPTEMBER 1980

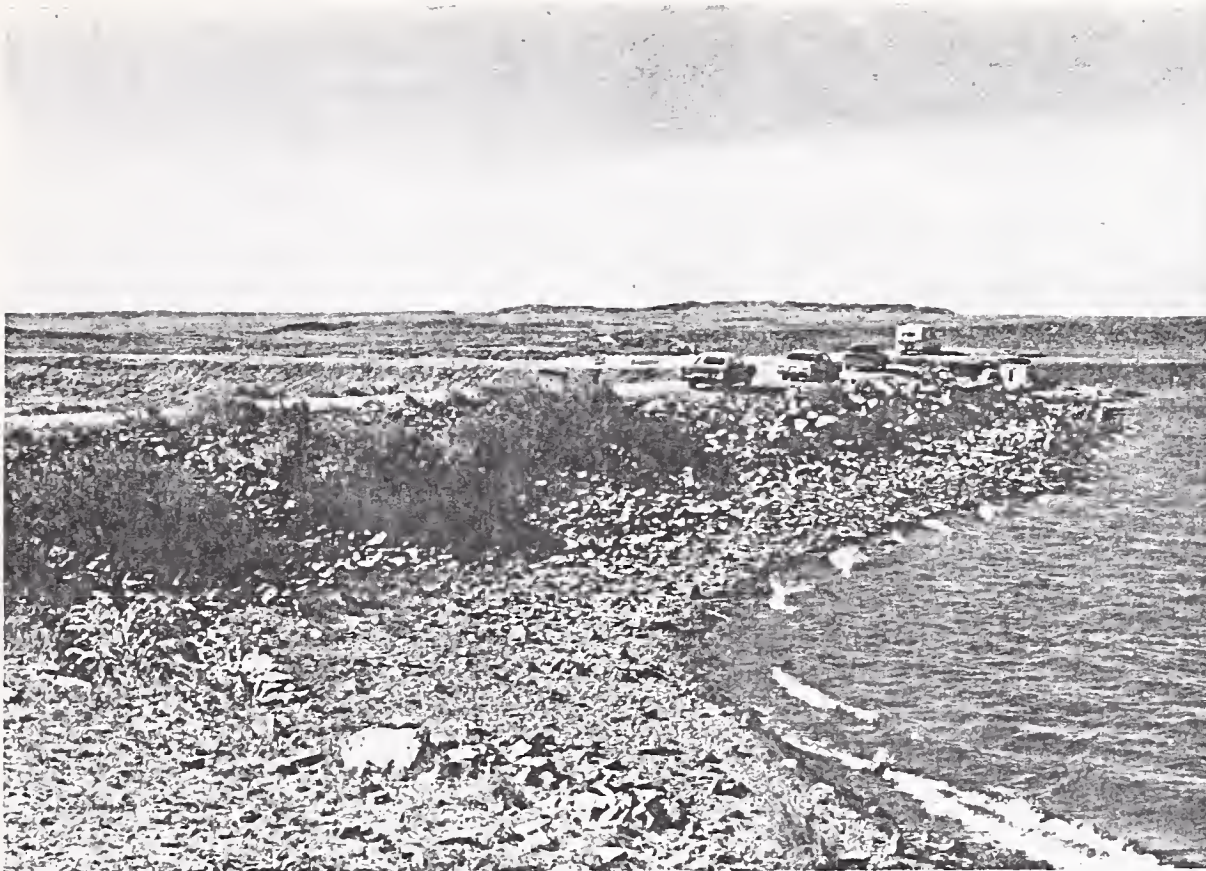
Photo No. 3 - Upstream Face and Dam Crest

At an isolated location on the upstream face of the embankment, the riprap has moved downslope along the embankment leaving the slope exposed and oversteepened (Photo 2, 3, and 25). This entire area, as identified on Exhibit D3, needs to be repaired.

The crest of the embankment turns to the southwest near this point, then again to the south near the 3 autos (see also Photo No. 1). The tops of several campers and trailers are visible. These vehicles are parked in the spillway.

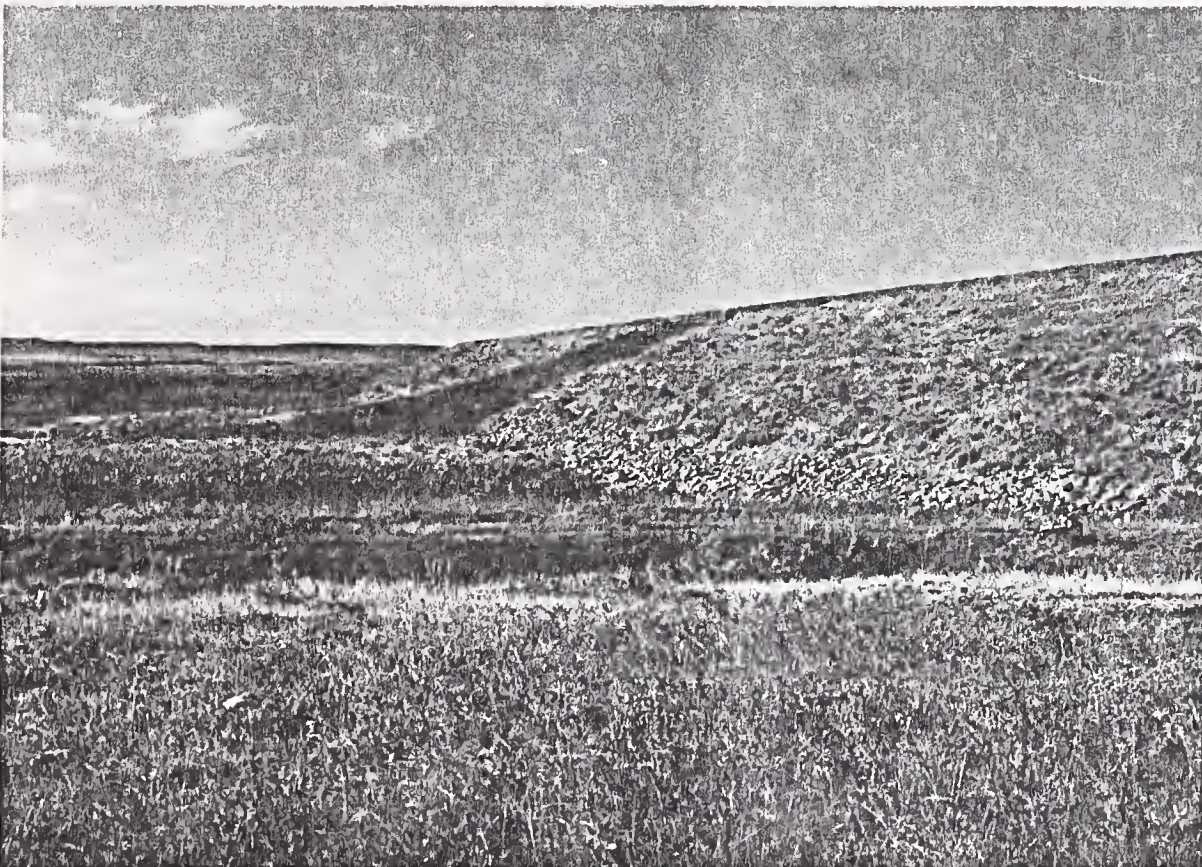
Photo No. 6 - Dam Embankment

Clear seepage water was observed exiting from the rock toe of the main embankment section (Photos 5, 6, and 7). This seepage is controlled by a main drain, which is parallel to the dam axis, and a series of lateral gravel drains which are perpendicular to the axis. The drain system is located at the base of the pervious fill section for controlled collection and discharge of seepage water to the pervious rock toe. Seepage was observed along most of the rock toe (Photo 28). This condition has saturated the foundation soils along the downstream toe. Evidence does not suggest that a significant amount of seepage is passing under the structure.

The rock toe is visible at the base of the embankment. Outlet works return channel is located in the center of photo, running from photo edge to edge.

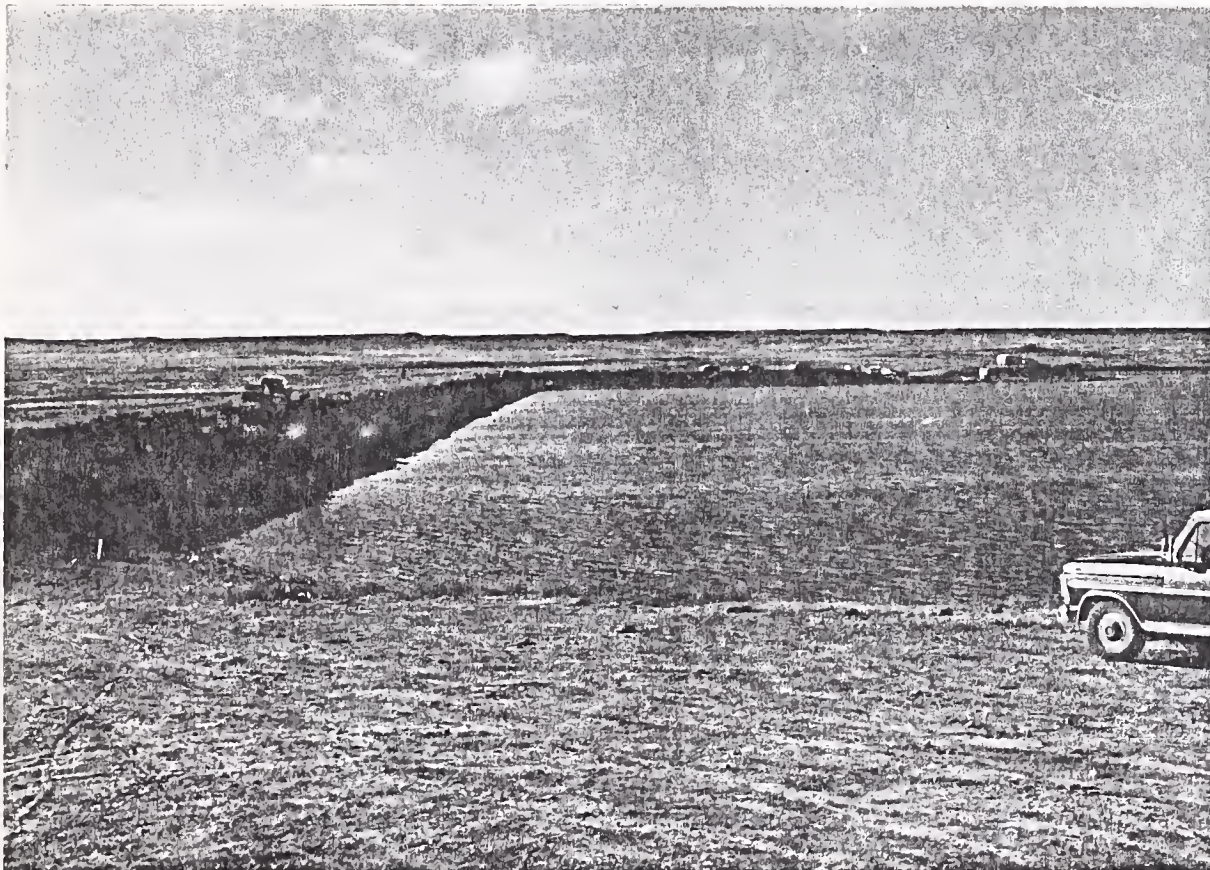
Photo No. 8 - Reservoir Basin and Shorelines

First in a 3-picture series. Standing on left (north) side looking south along dam. Similar to Photo No. 1.

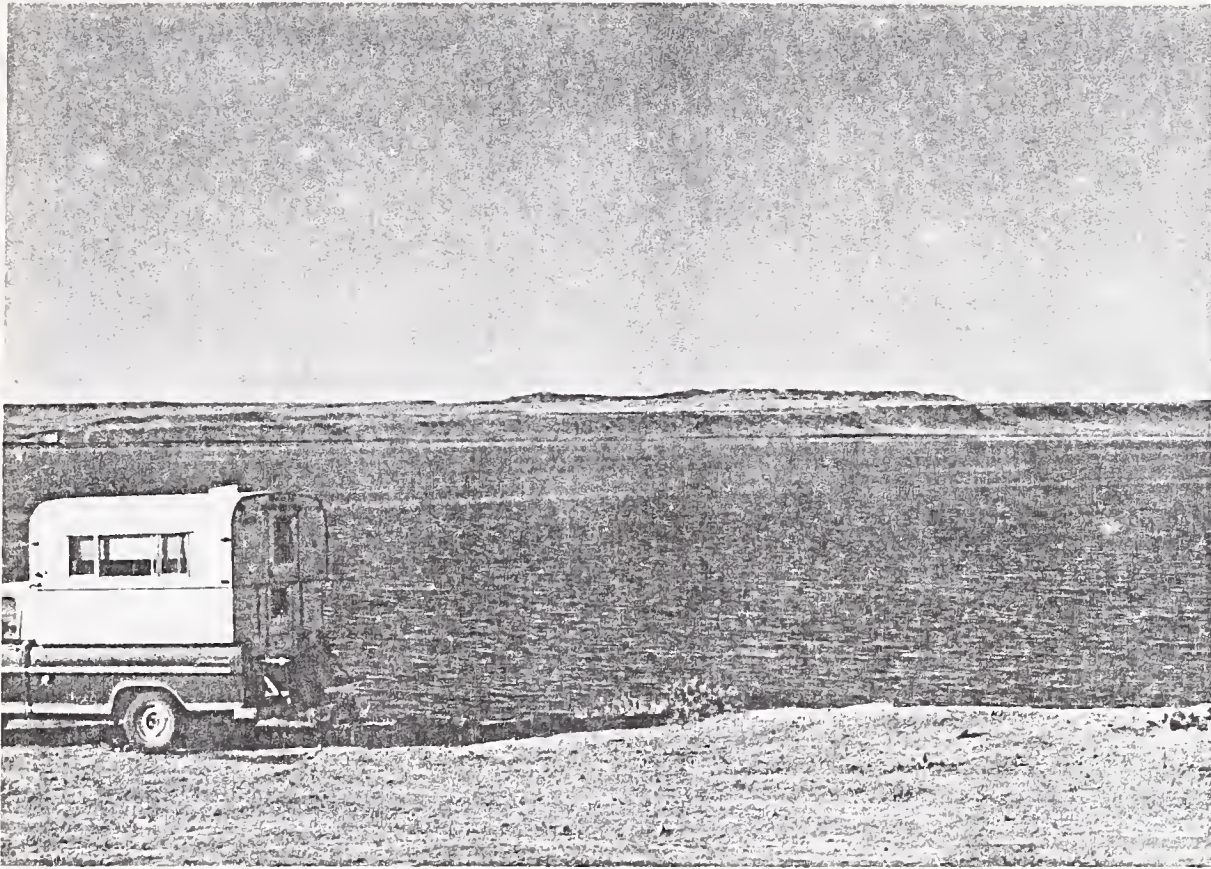
The reservoir shorelines are considered to be in stable condition as no major slides or scarpments were observed. The shoreline is occasionally vertical, or near vertical, and localized sloughing occurs due to wave action and saturated conditions (Photos 9, 10, 11, 12, and 21).

Photo No. 9 - Reservoir Basin and Shorelines  
 Second in a 3-picture series. Standing on left side  
 looking at south shoreline.

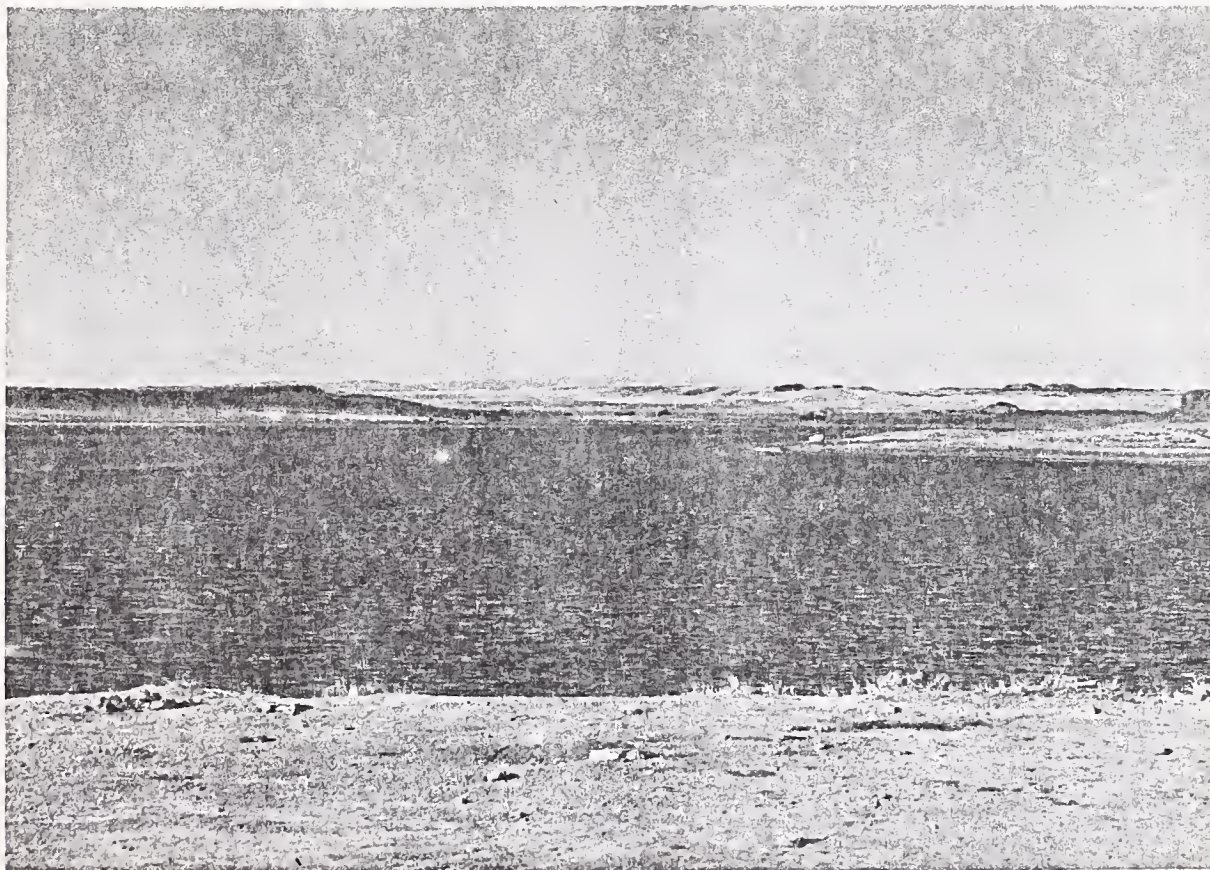
Photo No. 10 - Reservoir Basin and Shorelines  
 Third in a 3-picture series. Notice the local terrain  
 is flat and rolling, and vegetated primarily with natural  
 grasses.

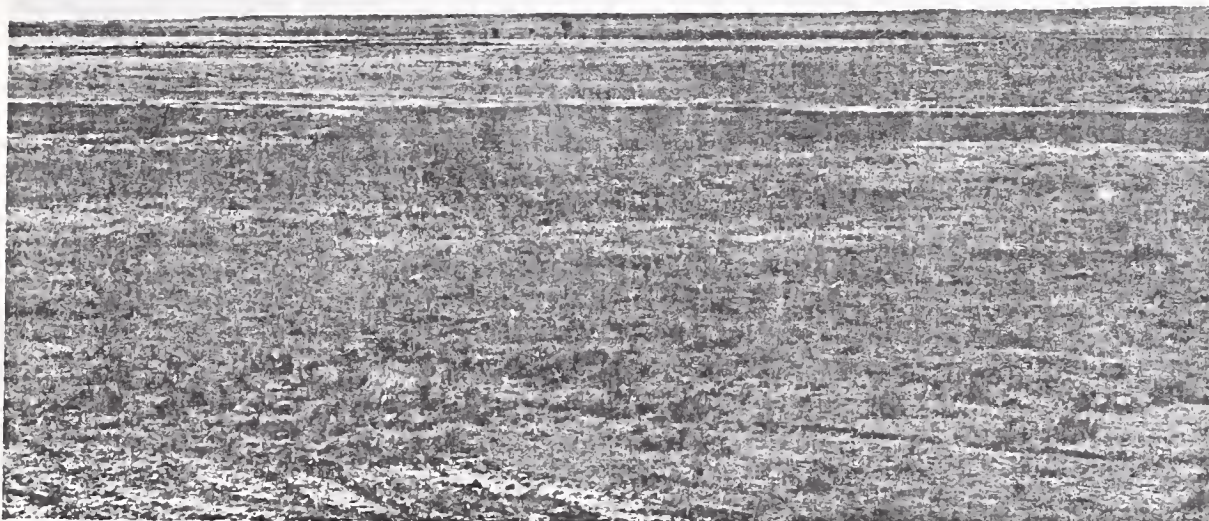
Photo No. 13 - Downstream Valley

The valley is shallow and broad. Vegetation consists of natural grasses and sagebrush. There are no farmsteads visible from the dam.

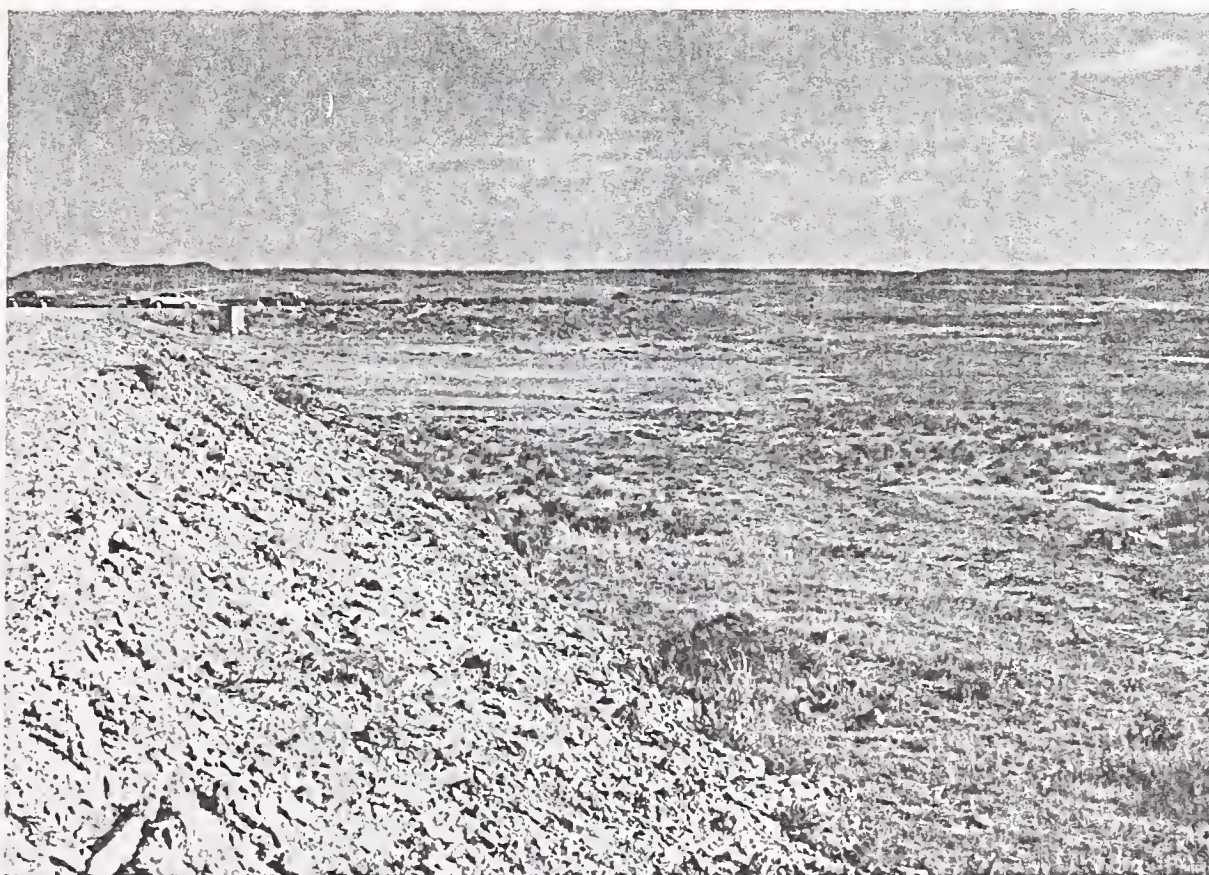
Photo No. 14 - Downstream Valley

First in a 2-picture series. Looking north along the downstream face of the new embankment spur. This spur forms the left (east) channel bank of the spillway. Notice the lack of vegetation on the face of the new embankment. Notice the 3 autos (see Photo No. 1).

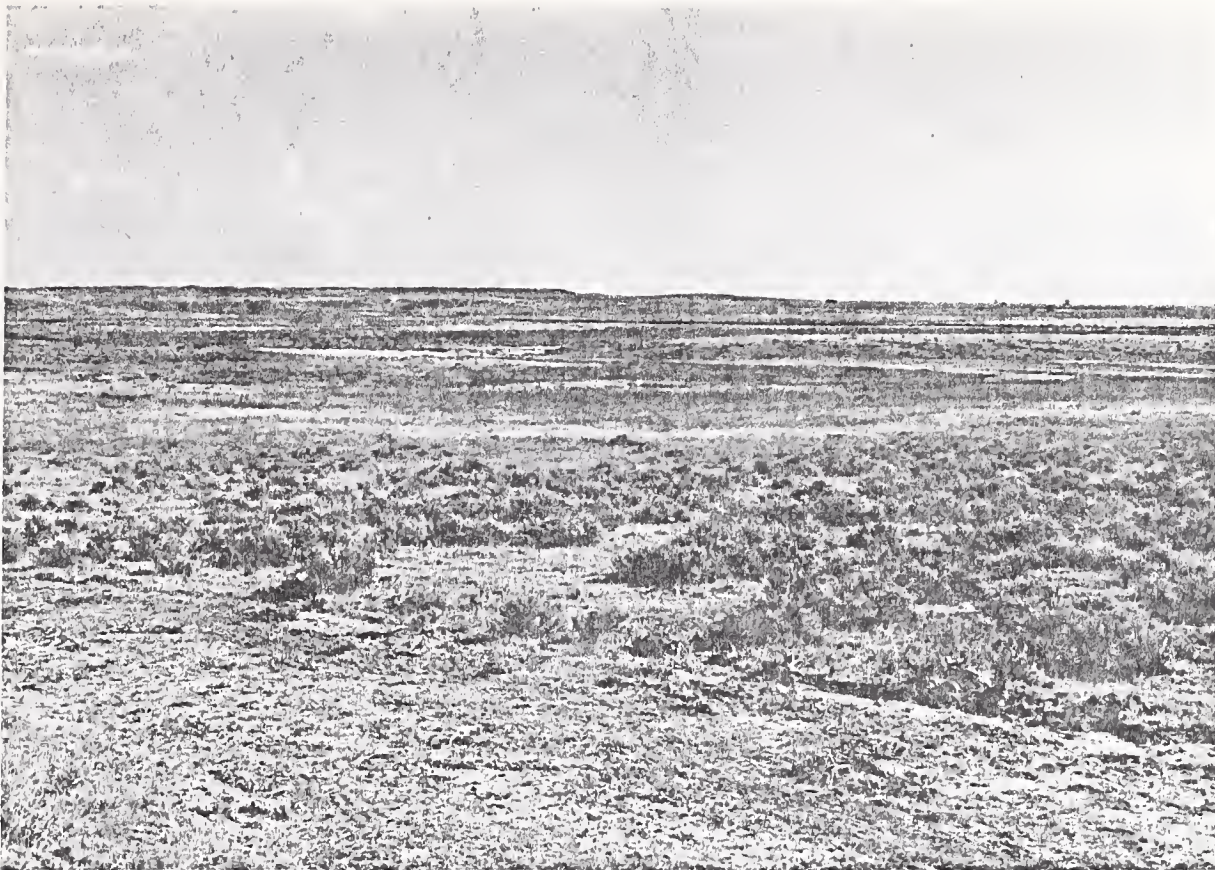
Photo No. 15 - Downstream Valley  
Second in a 2-picture series.

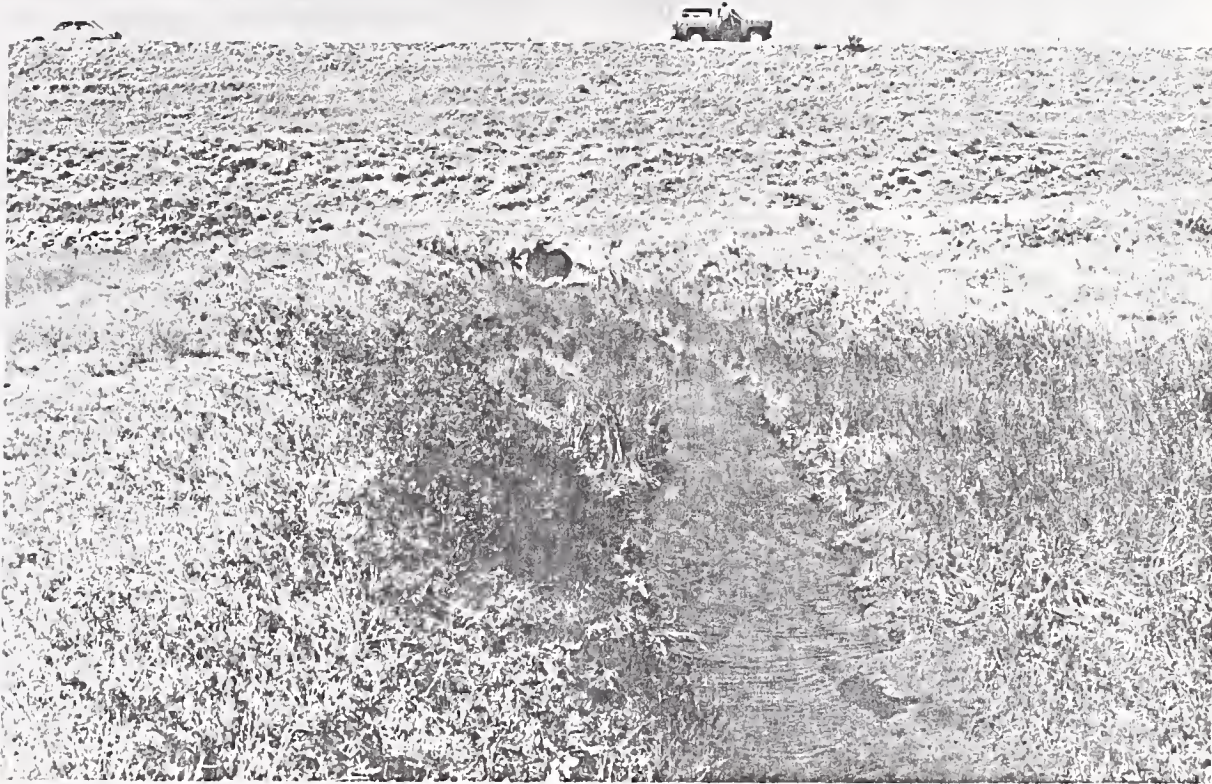
A small irrigation canal conveys the reservoir releases downstream as part of the irrigation delivery system. The canal is unlined, is trapezoidal in shape, and has well vegetated banks. Other than some bank sloughing, the canal appeared to be in good condition (Photos 16 and 17).

The side slopes of the downstream irrigation canal have subsided, but appear to be presently stable with an adequate vegetative cover (Photo 17).

Photo No. 17 - Outlet Works Return Channel  
The outlet diversion conduit serves as the low-level outlet for the dam.

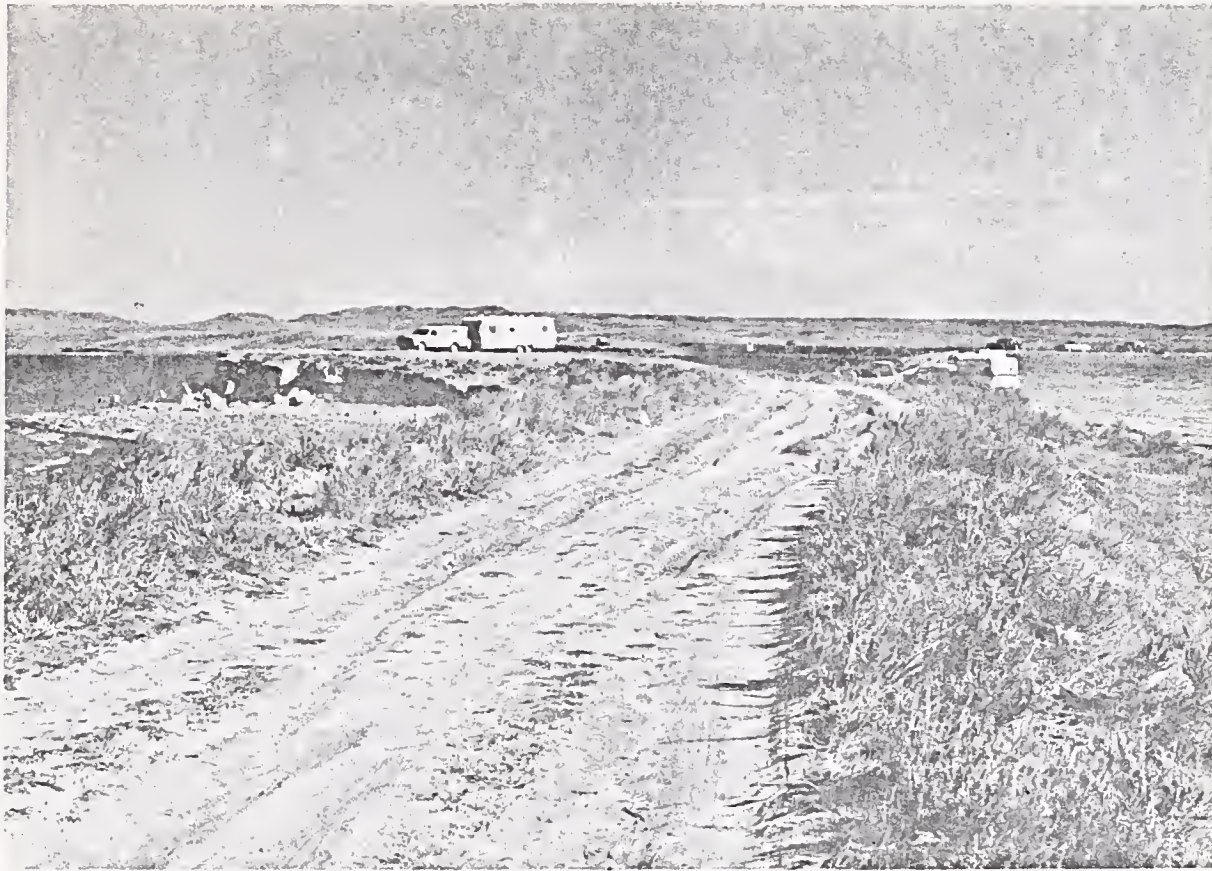
Photo No. 21 - Right Bank of Spillway and Spur Dike  
Looking north along the top of the right bank of the spillway. This is also the spur dike for the dam. The spillway is visible on the far right of the photo.

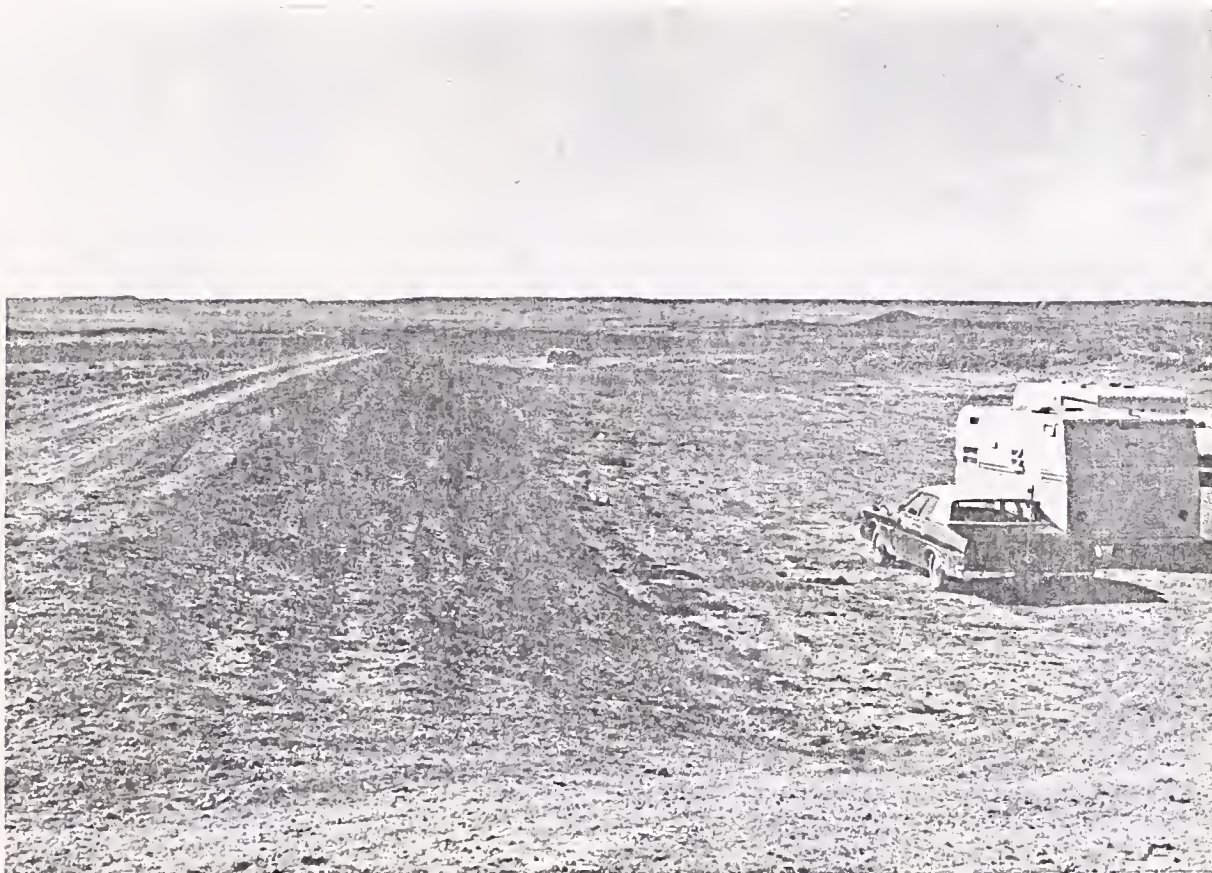
Photo No. 22 - Left Bank of the Spillway  
Looking south along the upstream side of the new embankment spur. The vehicles in this photo are in the spillway channel.

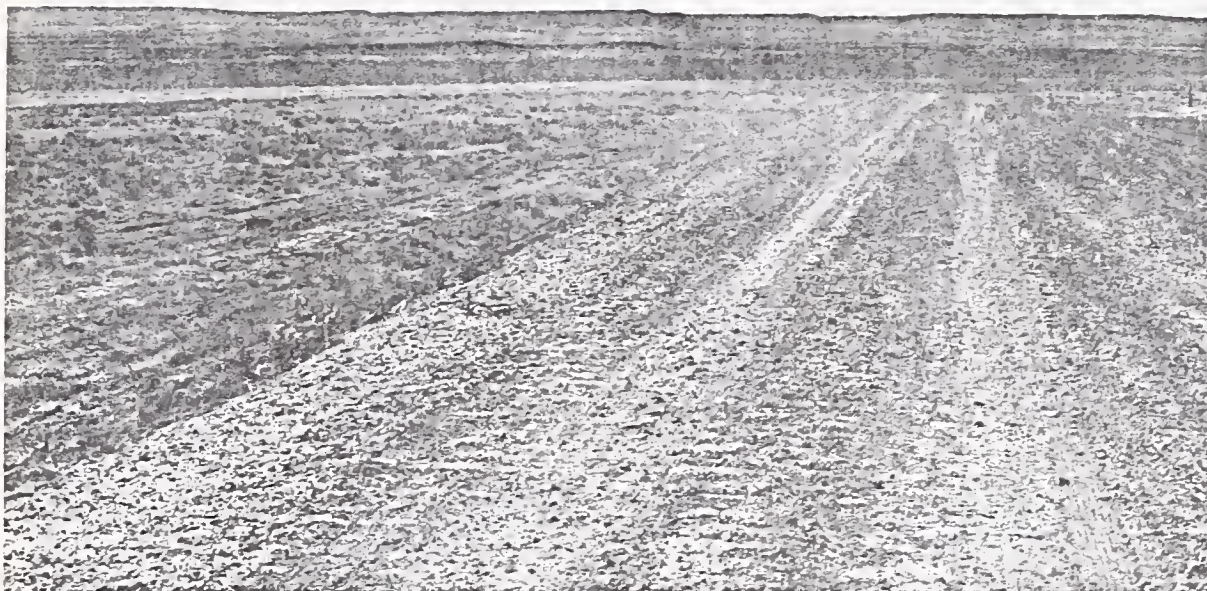
Photo No. 23 - New Embankment Spur

The foreground is the crest of the new embankment spur.  
The background is the area downstream of the spillway.
